**MARINE INVESTIGATION REPORT
M05C0019**

STRIKING

**BULK CARRIER *FEDERAL SAKURA*
SOUTH SHORE CANAL
ST. LAWRENCE SEAWAY
03 JUNE 2005**

Report Number M05C0019

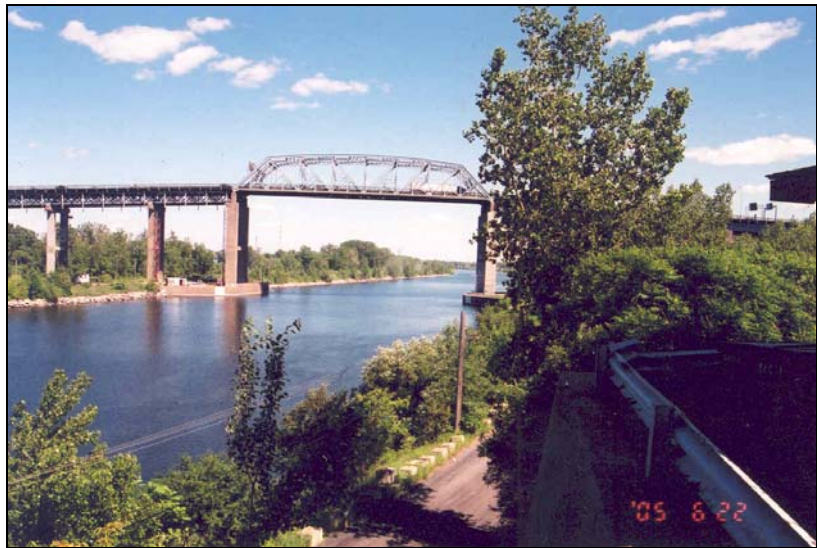
Photo 1. View of the Honoré-Mercier Bridge (Bridge 6) from the control tower

In the meantime, at 1752, the bridge operator managed to raise the lift span of Bridge 7B but was unable to raise the lift span of Bridge 7A. At 1758, the vessel had no headway, and the stern brushed the south pier of the Honoré-Mercier Bridge, without sustaining any damage. Subsequently, the vessel was manoeuvred to the centre of the channel, some 100 metres from Bridge 7A.

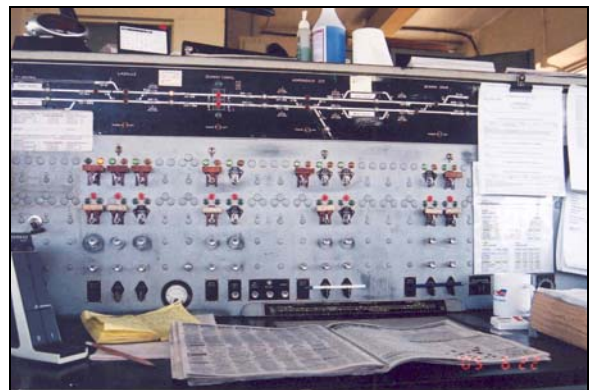
Photo 4. Mimic panel used to interlock and switch tracks
